Crop and Print Image

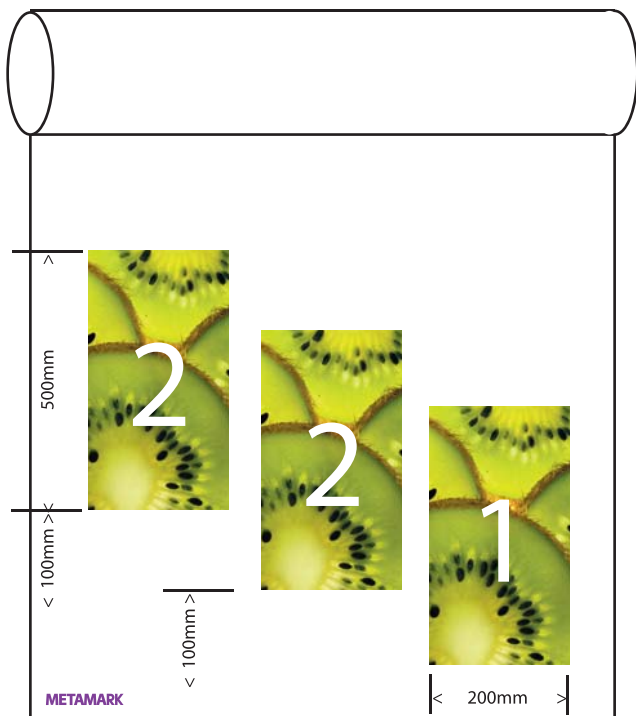
1. Crop and print the Image (1) approx 200mm x 500mm, close to the problematic edge of the roll. Repeat again if banding does not appear.
2. Start a repeat print again (2) this time 100mm into the roll, to the left. Repeat if necessary until banding shows.

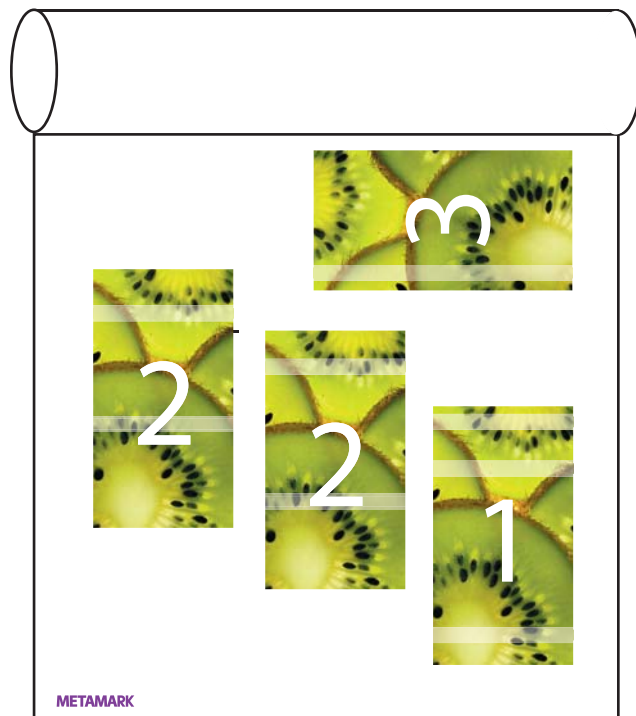
Cause: - Printer issue

If the bands appear in a different place on the roll on each print as shown here then it is a printer issue or an image issue.

Print the same image rotated 90°, to the right of the roll (3). Check where banding appears. If it hasn't rotated as shown then it a printer issue.

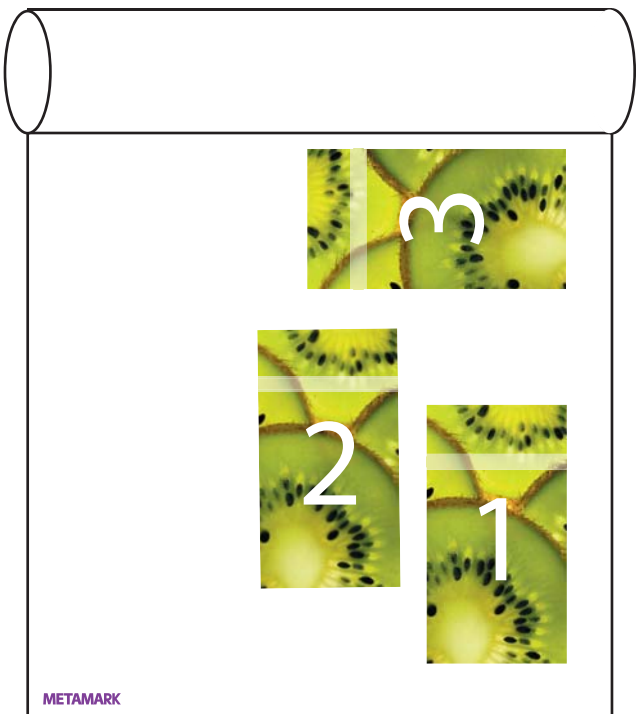
Cause: - Image issue

If when rotating the image (3) the band has also rotated then it is in the image - the band will appear in the same place in each image.

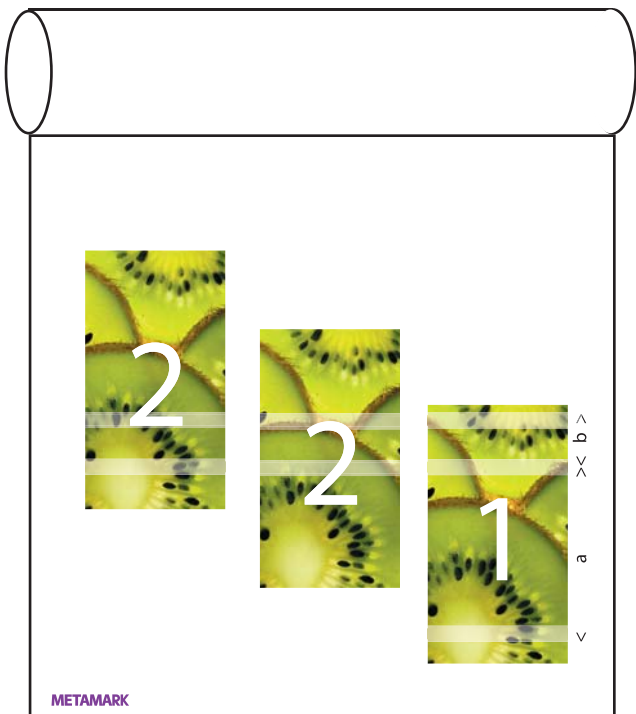
Cause: - Media or handling issue

If banding appears in the same place on the roll on both prints as shown here then it is handling or media.

A) Handling issue - compare spacing on the prints (shown by 'a and b') with circumference of roll / spacing of unwind rollers.

B) Media Issue - If the bands are not spaced as above then it is a coating issue. You can double check by cutting 1m off the roll and turn 90° then feed again
